MITCHELL FIELD WATER TOWER ASSESSMENT

Report of Findings

230515.00
Town of Harpswell, ME
March 2017

Mitchell Field Navy Facility Tank 100,000 Gallon Elevated Tank Condition Assessment Report

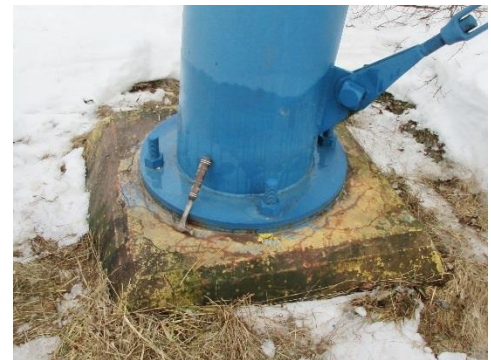
Photo 4 – SW Foundation Pier

1. Column Leg Pier Foundations: The concrete piers were found to be in fair to poor condition. Each pier had varying degrees of surface defects on the top and exposed sides of the pier, including spider cracking (or “crazing”), hollow concrete, spalling, and evidence of moisture penetration through surface cracks (white staining or “efflorescence”). Approximate estimates of the percentages of hollow concrete for each pier are as follows: Southwest (SW) Pier – 75%; SE Pier – 50%; NW Pier – 25%; NE Pier – 50%. Minor spalling was observed on the corners of the SW & NE piers. Conditions of below-grade portions are unknown. It appears that the concrete was originally coated, but only small portions of the blue coating are still intact. The painted steel column legs and anchor bolts are in fair condition with no major signs of corrosion or structural weakness; the paint is worn and faded, but the lower portions exhibit only minor levels of surface corrosion.

2. Column Leg Pier Foundations: The extensive cracking in these foundations makes them susceptible to future moisture penetration and damage, with some evidence that this has already been occurring for many years to varying degrees. All areas that are cracked, hollow, spalled, or otherwise unsound shall be chipped down to a depth as required to achieve a sound, durable concrete substrate. It is anticipated that the perimeter of the piers should be dug down approximately 12" to expose the foundation and inspect condition. Once the unsound areas are delineated, the perimeter of all repair areas shall be saw-cut to a depth of 1". All areas inside each repair area shall be chipped out to a uniform depth of no less than 1", but deeper for areas where necessary to find sound concrete. If reinforcing is encountered during demolition, it will be inspected, cleaned, and coated with an anti-corrosion bonding agent. Any repair areas deeper than 2" shall be reinforced with nominal steel reinforcing (#4 @ 12" on center) to mechanically bond new concrete to existing concrete. Sides shall be formed with plywood to match existing pier wall geometry, including the edge chamfers. Epoxy bonding compound should be applied to all existing concrete substrates to enhance bond. New high-performance repair mortar shall be installed to restore lost concrete as required to match the pier's original geometry. After proper curing is complete (minimum of 7 days), it is recommended that all exposed-to-view concrete be coated with an elastomeric polyurethane coating to provide added moisture protection to the concrete. The painted steel superstructure should be prepared and repainted in the next 3-5 years.

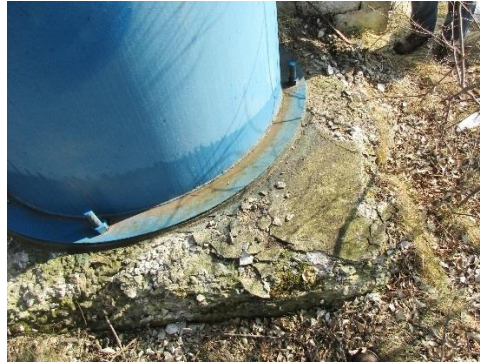
Photo 7 – Riser Foundation SW Corner

2. Center Riser Foundation: The concrete surrounding the riser pipe is very poor condition with extensive deterioration, erosion, and spalling, which has resulted in several inches of material loss in many areas. The concrete that remains is very weak, unstable, porous, and unsound, indicating that much or possibly all of it will need to be replaced. As discussed in the Existing Construction section above, the configuration of the concrete below grade is unknown. The concrete slab extends into the concrete block wall of the adjacent utility building, so any demolition and repair of this foundation will affect and need to be coordinated closely with the building should it remain. The painted steel riser pipe and anchor bolts are in fair condition with no major signs of corrosion or structural weakness.

construction drawings and the actual conditions. We recommend that a repair contractor be retained to do some preliminary exploration, under the supervision of a structural engineer. This would involve digging a test pit along the side of the concrete slab (assume 4' deep) to determine the depth of the concrete encasement and to also observe the condition of the concrete below grade to be compared with the above grade condition (very poor). It is assumed that excavation would be provided by the Town's Public Works crew. In addition, it is recommended that a minimum of three test holes be drilled through the slab around the riser base plate to identify the slab depth and what exists below (soil, vault space, or solid concrete). Since the original drawings are not accurate, this field exploration will enable us to make more sound decisions on how best to repair these foundations and better understand the related cost implications. It will also give us better insight as to the structural integrity of the existing riser pipe support.

3. Center Riser Foundation: Before the riser foundation is repaired, the adjacent utility building should be demolished (see Item 4 below). The results of the Preliminary Test Pit Exploration recommendations outlined in Item #1 will be used as a basis for developing the repair strategy for this foundation. However, it is assumed that the concrete slab around the riser will be demolished for a depth of at least 12" and to a point close to the riser base plate perimeter. Any existing rebar will be left in place during concrete demolition, its condition inspected, and salvaged for re-use (or replaced in kind if compromised). Once sound concrete is achieved below, or the bottom limits of the slab thickness are exposed, edge forms will be installed and new 4000 psi concrete will be placed to match the original slab geometry. Please note that both design recommendations and pricing of this portion of the work is dependent upon the results of Recommendation #1. Furthermore, even after this exploration there may be some unexpected conditions encountered during construction that may require additional work and expense. The painted steel superstructure should be prepared and repainted in the next 3-5 years.

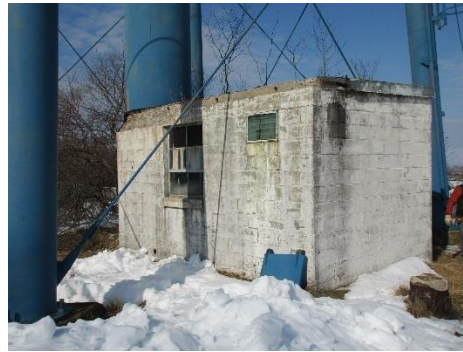
Photo 9 – Utility Building Exterior

3. Concrete Block Utility Building: This building is in poor condition. The sloped cast-in-place concrete roof slab has major deterioration on its edges, evidence of cracks with moisture damage on the underside of the slab and perimeter concrete, and has likely endured many years of moisture penetration through the roof. The concrete block walls show signs of deterioration and moisture damage. The wood doors and windows are in very poor condition, while the floor slab is in fair condition. Though out of the scope of this assessment, it is also assumed that the electrical panel and wiring is in need of updating.

4. Concrete Block Utility Building: This concrete block building is in poor condition and should be demolished in its entirety down to the concrete foundation (which can remain). Other utilities, such as electrical, shall be demolished or upgraded (by an electrical contractor) for an exterior exposure if necessary, unless the building is to be replaced. Note that if this building is not demolished, it will complicate the center riser foundation repairs since that slab is integral to the west building wall.
